TVA System Status Update

2018 Summary

January 1 – December 31, 2018

2019 Summary

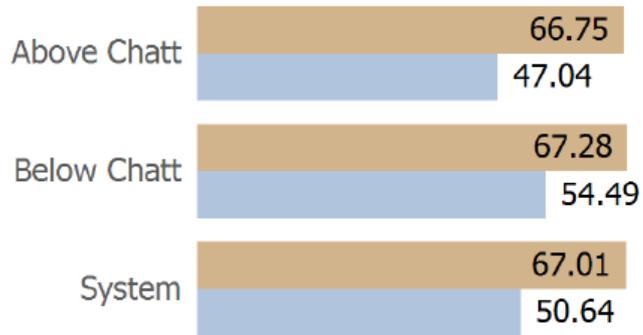
CYTD Observed Rainfall vs. Normal

Location	Observed (in)	Normal (in)	Normal (%)
Above Chatt	66.75	47.04	141.92%
Below Chatt	67.28	54.49	123.48%
System	67.01	50.64	132.32%

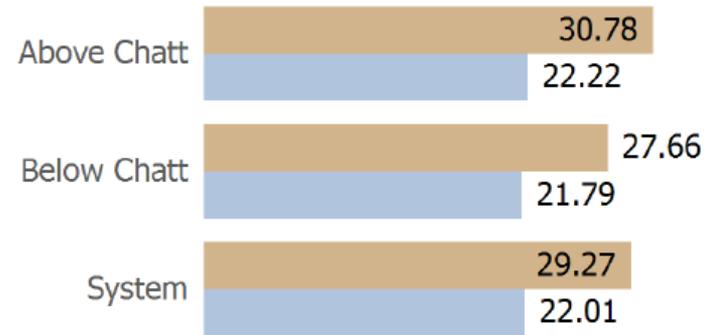
CYTD Observed Runoff vs. Normal

Location	Observed (in)	Normal (in)	Normal (%)
Above Chatt	30.78	22.22	138.54%
Below Chatt	27.66	21.79	126.91%
System	29.27	22.01	133.01%

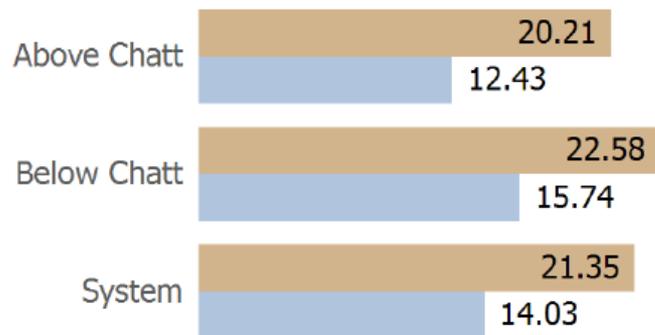
CYTD Observed Rainfall vs. Normal

Location	Observed (in)	Normal (in)	Normal (%)
Above Chatt	20.21	12.43	162.54%
Below Chatt	22.58	15.74	143.48%
System	21.35	14.03	152.15%

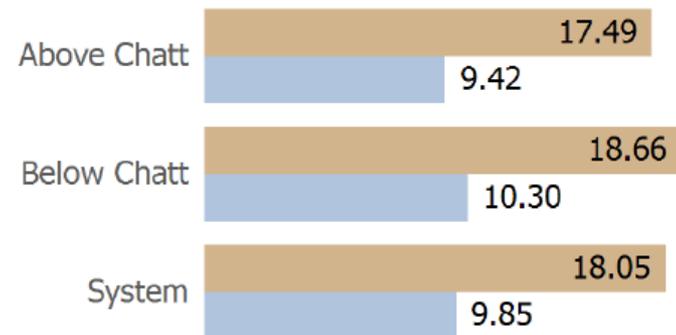
CYTD Observed Runoff vs. Normal

Location	Observed (in)	Normal (in)	Normal (%)
Above Chatt	17.49	9.42	185.62%
Below Chatt	18.66	10.30	181.11%
System	18.05	9.85	183.30%
